# TECHNICAL BULLETIN

## Understanding Normal Seasonal Gapping in Engineered Hardwood Flooring

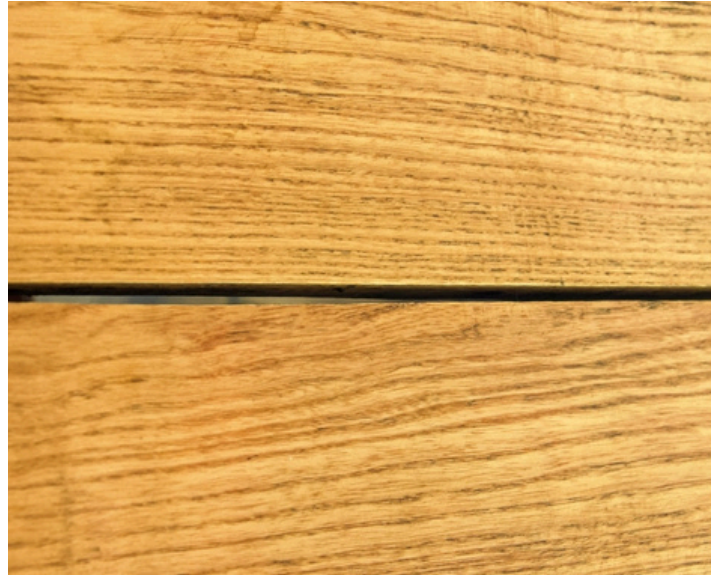
Gaps that appear between individual boards, opening and closing with seasonal humidity changes. Wider boards can experience wider gaps. Gap size is directly related and proportional to the board width.

Most normal gaps are caused by seasonal fluctuations in relative humidity. The floor expands with high humidity and contracts with periods of low humidity. This type of expansion and contraction is considered to be normal and expected with wood floors when exposed to seasonal variations.
