October 2013 Vol. 55 No. 7

## The 10 MOST COMMON Waterproofing Mistakes for Hard Surface Installations

By Dale Kempster, CSC, CTC, TTMAC

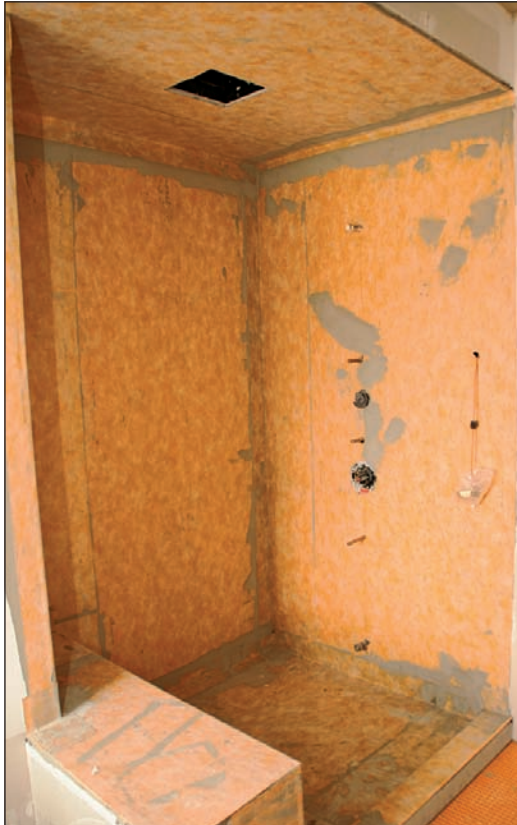
Steam showers must be constructed with a vapour retarder that has a perm rating of 0.5 or less at 90 percent relative humidity (RH).

This is a big misunderstanding that can be especially disastrous in continuous-use steam rooms and high-use residential steam showers. In the past, a vapour retarder for a shower being tiled directly onto, had to have a perm rating no greater than 1.0. With the latest revision of the Terrazzo, Tile, and Marble Association of Canada (TTMAC) 09 30 00, *Tile Installation Manual*, the requirement has been made more stringent—0.5 perm or less using ASTM E96, *Standard Test Methods for Water Vapor Transmission of Materials*, Procedure E, at 90 per cent relative humidity (RH).

The waterproof membrane manufacturer should be consulted to confirm its actual perm rating, and that the rating is based specifically on Procedure E of ASTM E96, as there are six different procedures under this standard. These different procedures are for various environments and applications, and Procedure E best suits the environment for a steam room at 37.8 C (100 F) at 90 per cent RH. (This is the highest temperature tested in any of the procedures.)

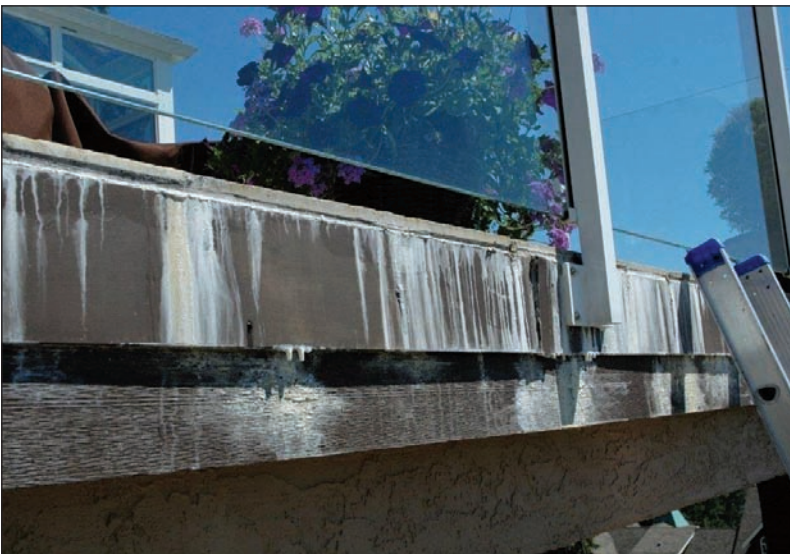
Inadequate moisture management can lead to efflorescence that destroys the appearance of the tile installation.

Efflorescence occurs when soluble salts in the mortar rise with moisture through the grout joints to the surface and deposit a white, or yellowish, residue. This residue can be difficult to remove and may even require use of a sulfamic or phosphoric acid. Efflorescence is a natural occurrence with any portland cement-based product, and the best way to control and prevent it is to manage the moisture.

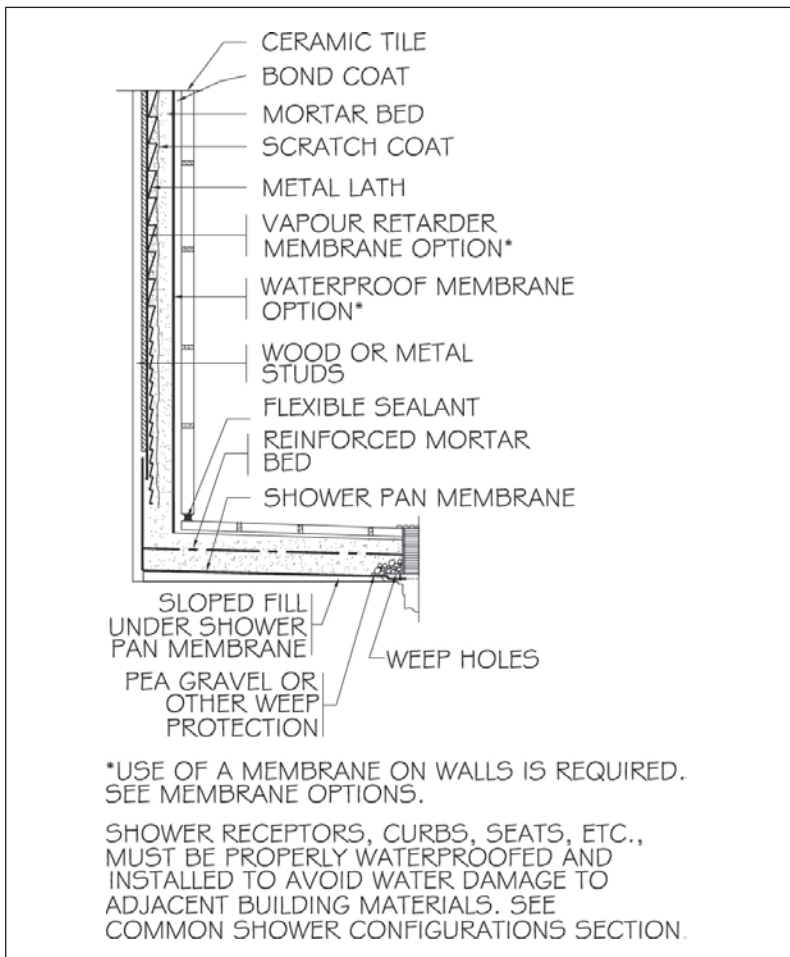
The pan-liner in a shower that was built using a traditional mortar bed must be pre-sloped to the two-stage shower drain.

When using a traditional mortar bed, there is a shower pan liner that needs to have a pre-slope of approximately two percent. This pre-slope is critical to ensure subsurface moisture can actively work its way to the two-stage drain used in this assembly. Additionally, weep holes must be kept open so moisture can evacuate from the area. This can be done easily by using a sub-surface drainage mat on the waterproofed pre-slope that provides rapid water drainage to the lower section of the two-stage drain.

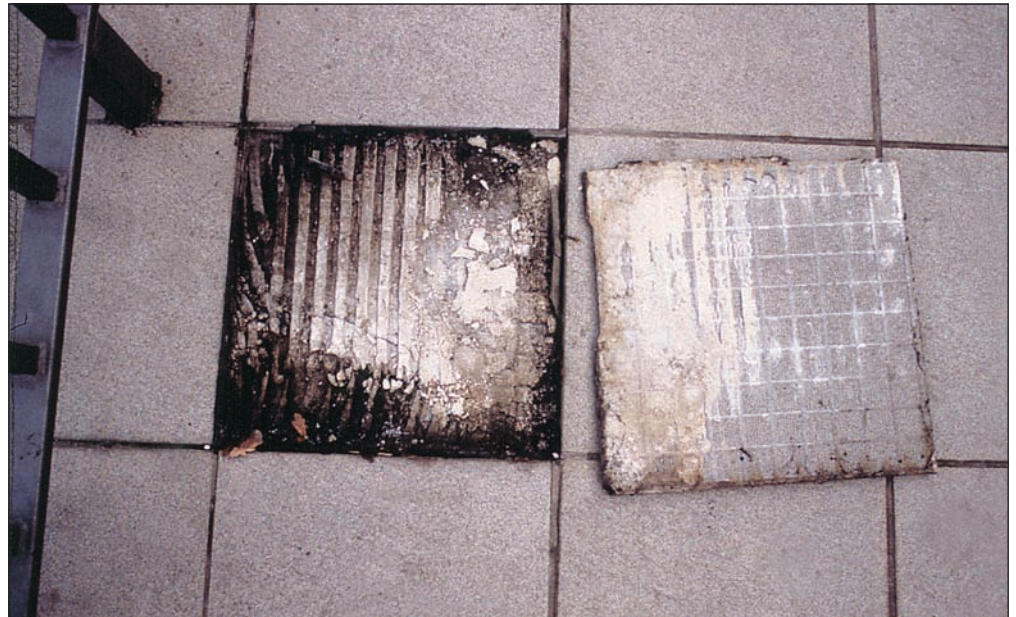
*Tiles in wet areas that do not have at least 95 per cent coverage are much more likely to come loose or break.*

The TTMAC 09 30 00 *Tile Installation Manual* specifies tiles installed in wet areas should have a minimum coverage of 95 per cent. For this to be accomplished, the tile typically needs to be back-buttered, meaning a thin coat of mortar is applied to the tile's back with the flat side of the trowel. When there is insufficient coverage, the tile or stone often displays some shading and, since the voids collect water, the chances for efflorescence increases. There is also a much greater risk of tiles delaminating, which represents a major failure and added cost for many projects.
